47<sup>TH</sup> TURBOMACHINERY & 34<sup>TH</sup> PUMP SYMPOSIA  
HOUSTON, TEXAS | SEPTEMBER 17-20, 2018  
GEORGE R. BROWN CONVENTION CENTER

# Steam turbine with 0.9X vibrations

This 15 MW steam turbine/gearbox/4-pole generator train, following a recent overhaul, was showing unusual phenomenon of high level 0.9X vibration during shutdown, as well as power limits due to vibration level increase. The case describes a single day\* field investigation program, that lead to identification of the root cause of the problem and pin pointed other problems with the quality of the overhaul. Vibration data are reviewed showing solution through application of standard\*\* methodology.

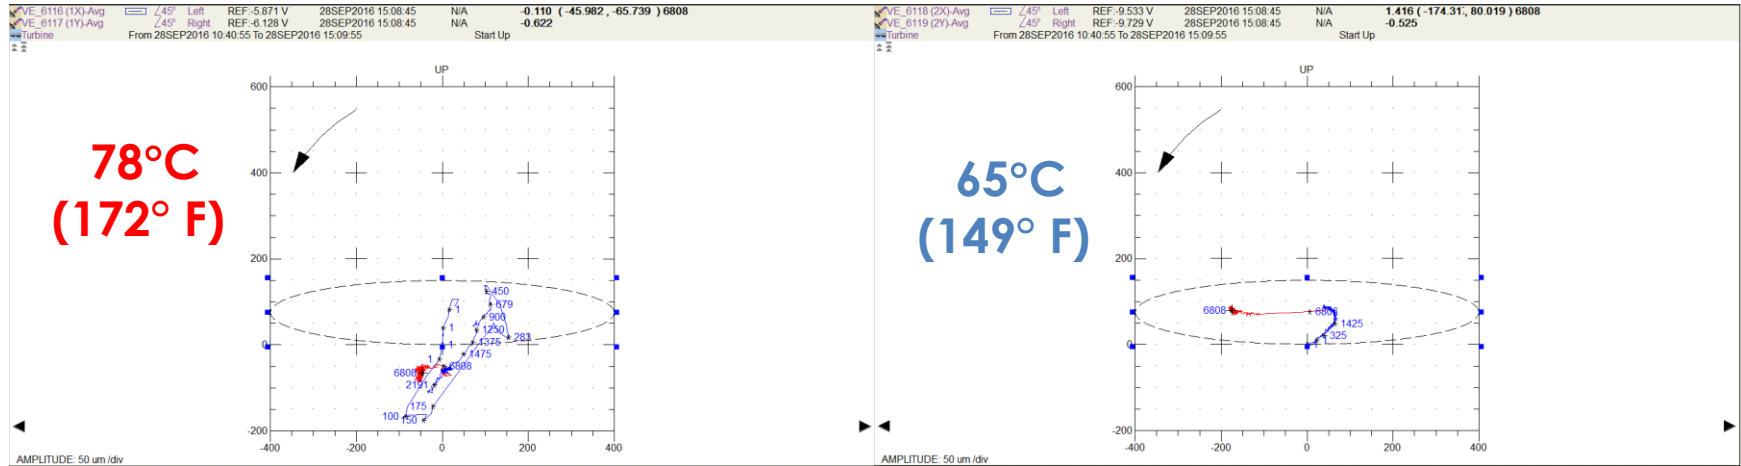
Note the proportions of bearing clearances. The elliptical bearing with high ellipticity (high geometrical preload) is local remedy to stability problems. Sometimes referred as “hyper-elliptical” design.

- Fluid induced instability (steam whirl) onset above 10MW. Known historical problem controlled by “hyper-elliptical” bearing design.
- Deterioration of bearing properties due assembly errors and/or high vibration events led to lowering of stability threshold.
- Suspected:
  - Bearing #1 overloaded, clearance reduced, possibly bearing tilted.
  - Bearing #2 “crush” reduced. And asymmetric clearances in the steam labyrinth seals.

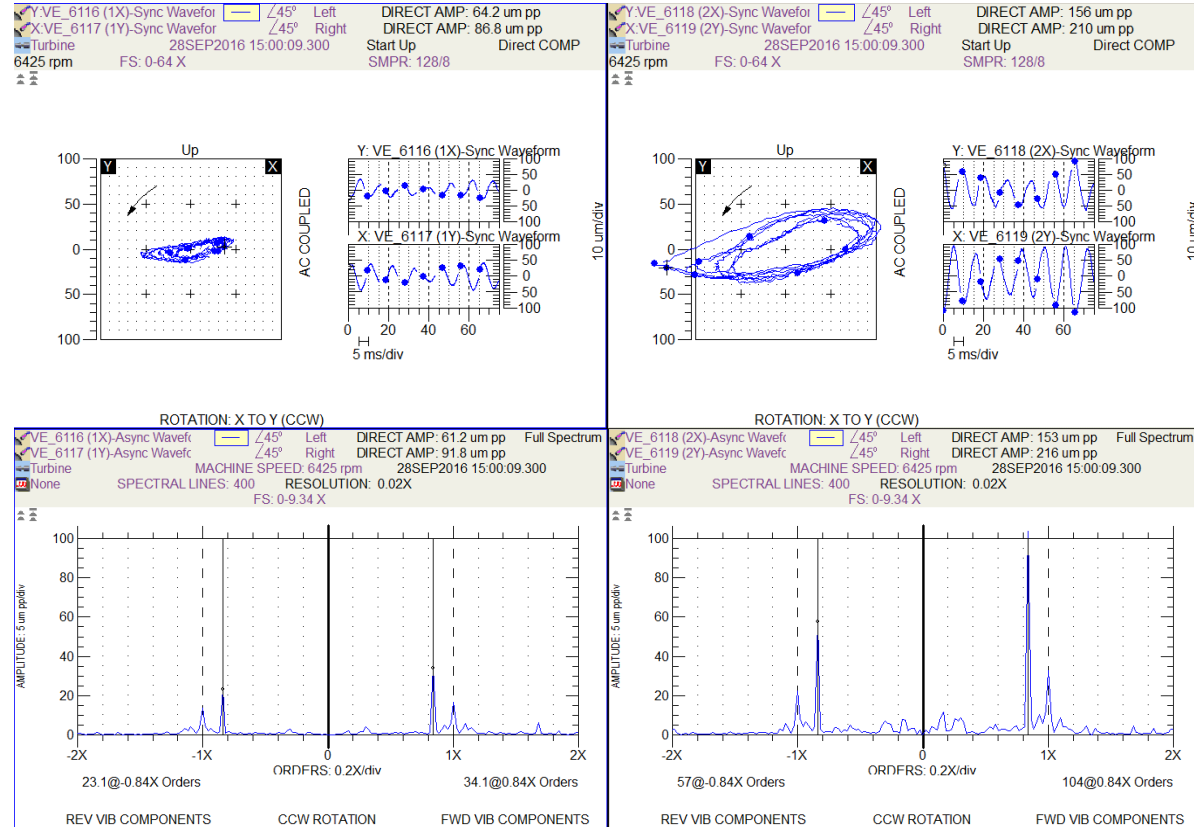
# Turbine brg. orbits as shutdown commences

- Subsynchronous
- Forward precession
- Preloaded shape
- Unusual frequency  
~ 0.9X

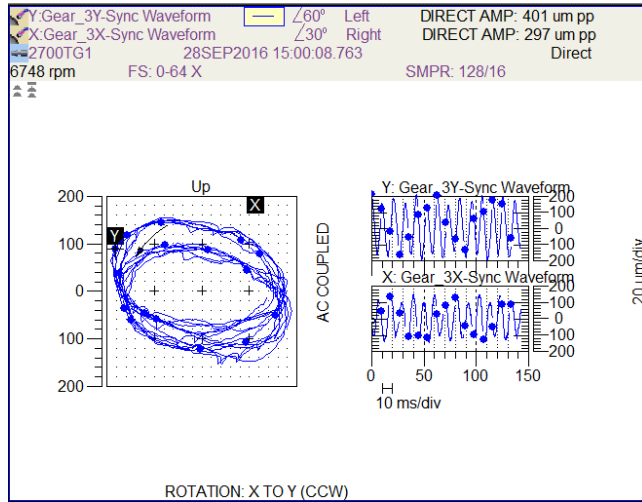
# Brg. #3 (pinion) vibration

Elliptical  
subsynchronous  
component,  
some 1X...

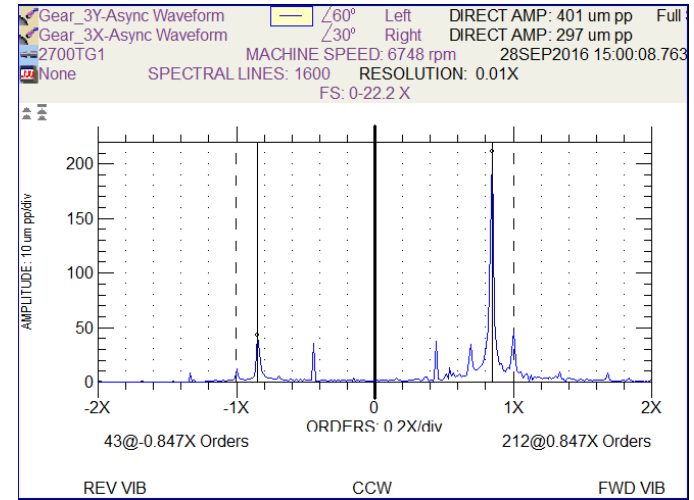
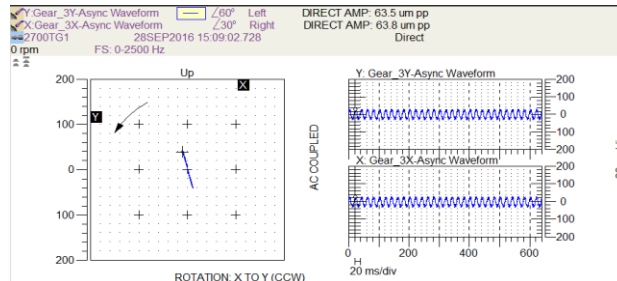
and 50Hz electrical noise  
(measured at stopped machine).

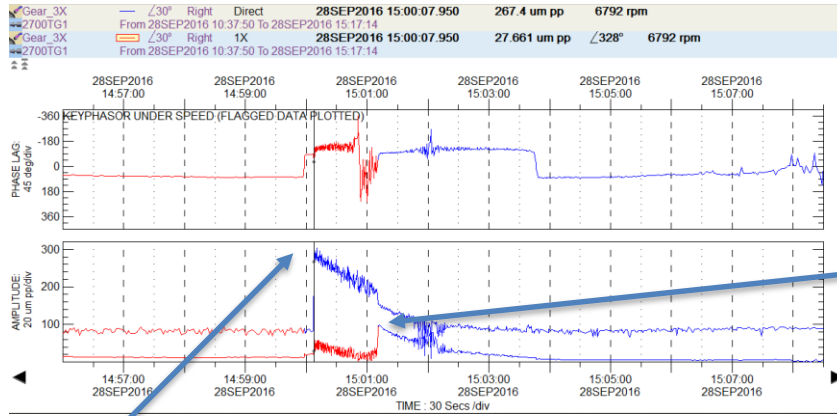
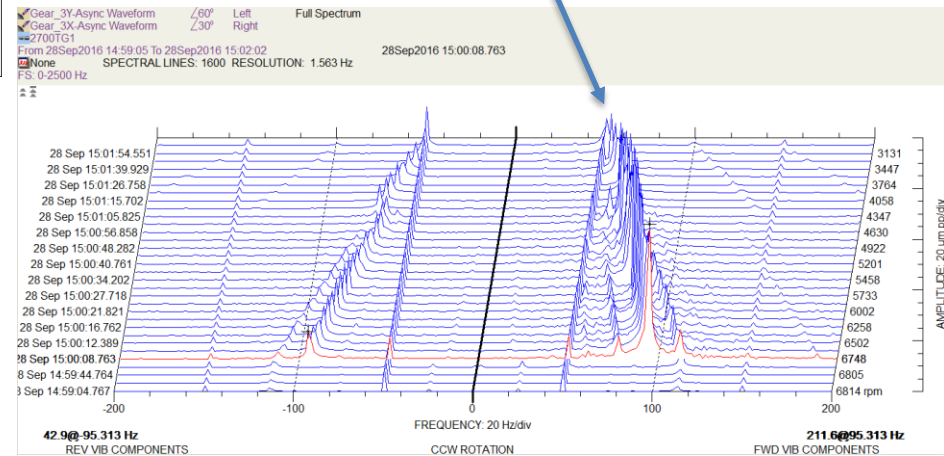
# Brg. #3 (pinion) vibration

Subsynchronous merges to 1X  
at ~ 4200 rpm

Vibration starts at the  
moment of shutdown

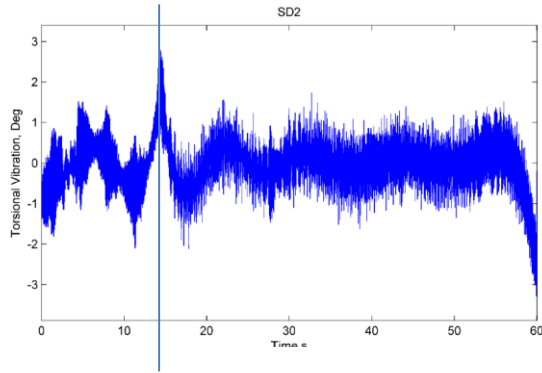
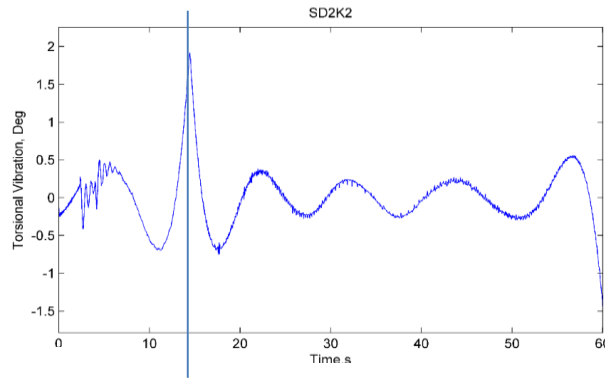
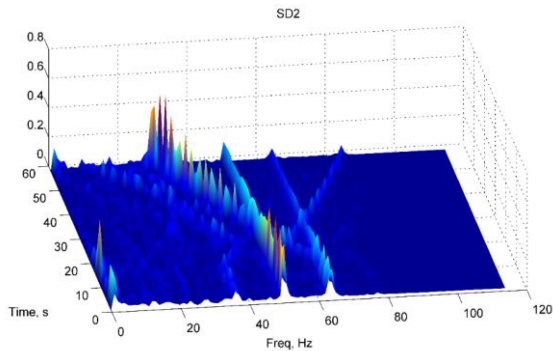
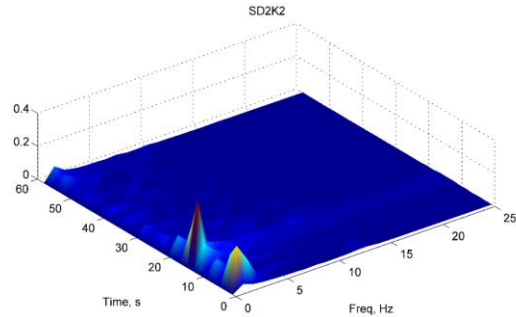
# Torsional vibration measurements

Time interval method (TIM) used for keyphasor events.

No torsional activity for  $\sim 0.1X$  (an alias for  $\sim 0.9X$ ).

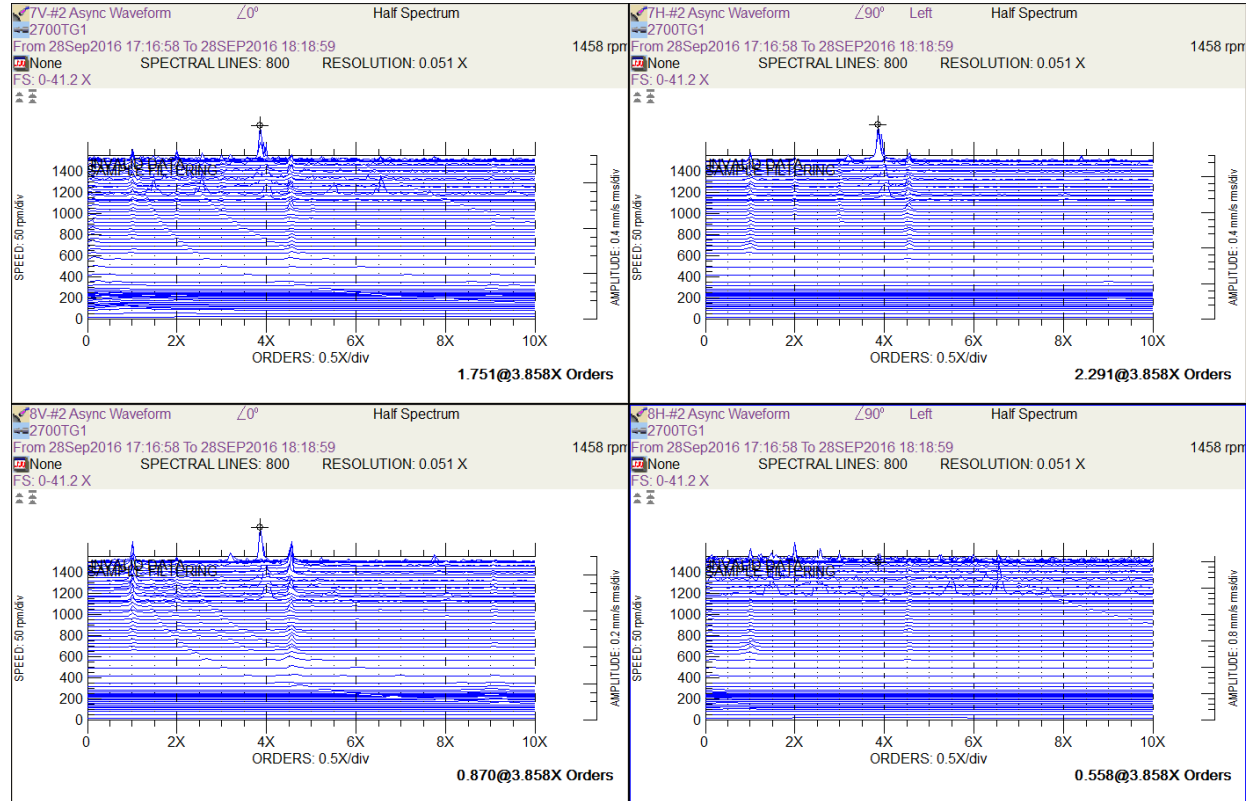
# In addition, based on casing vibration

The frequency of excited vibration is not generator 4X.

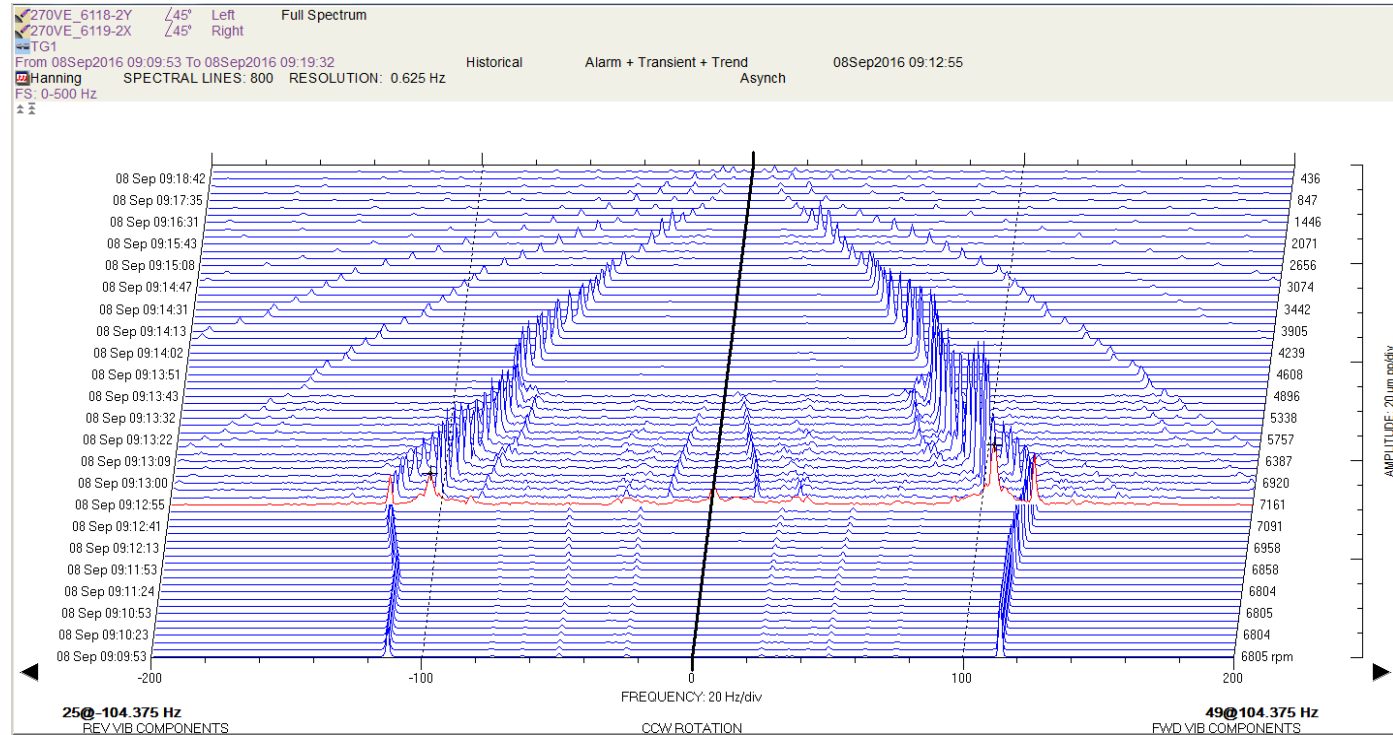
# In addition, from historical overspeed test

Same phenomenon, but generator was not excited during test.

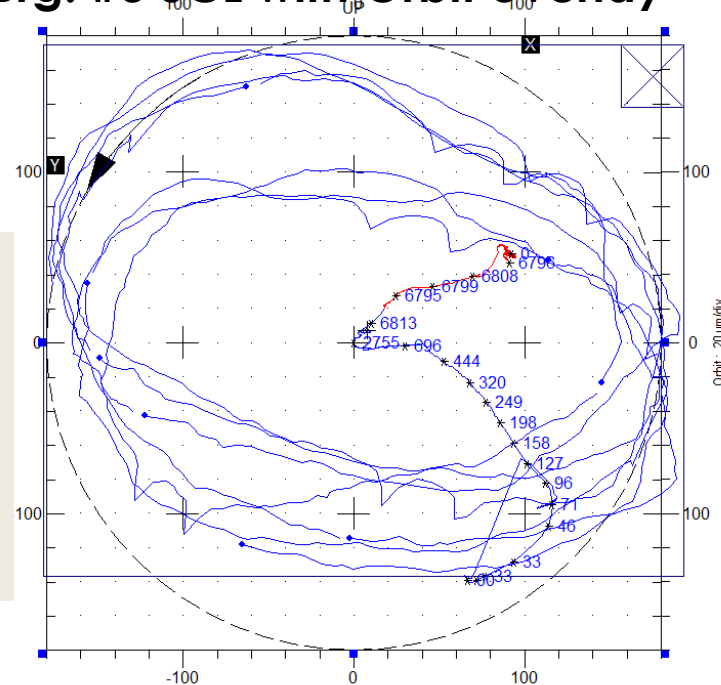
## Brg. #3 SCL with Orbit overlay

- Subsynchronous vibration
- In poorly loaded bearing
- Forward in precession
- Following the brg. clearance...

But the frequency is not matching known models.

- With the exception of average fluid velocity, typically near  $0.5X$ , the shaft vibrations at brg. #3 show all classical symptoms of fluid induced instability in unloaded bearing.
- Suppose the fluid is put into motion by  $1X$ , due to partially locked gear coupling.
- Key observation: for properly operating coupling, the vibration modes for turbine rotor and gearbox pinion should be de-coupled. Inspect the coupling.

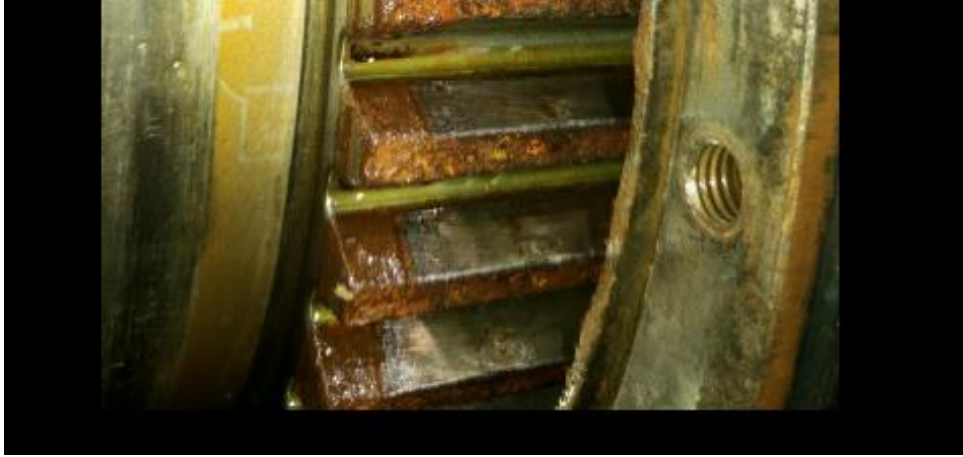
# Coupling condition/problem origin

Gear coupling ST/GB is "partially locking"	Confirmed, see next slide.

Steam leak from damaged labyrinth into coupling guard.  
Found 2.7% of water content in oil (at main oil tank).

- Turbine bearings and their clamps replaced by spares. Coupling cleaned, marks ground and polished. The teeth clearances ~ six times nominal values.
- Turbine in operation for more than year, till planned OH, with strict monitoring of oil quality. No subsynchronous excitation in operation nor in shutdowns.
- Next overhaul made with high quality standards. Rotor repaired by OEM, new bearings of original tilt-pad design, new coupling. Smooth operation since then.

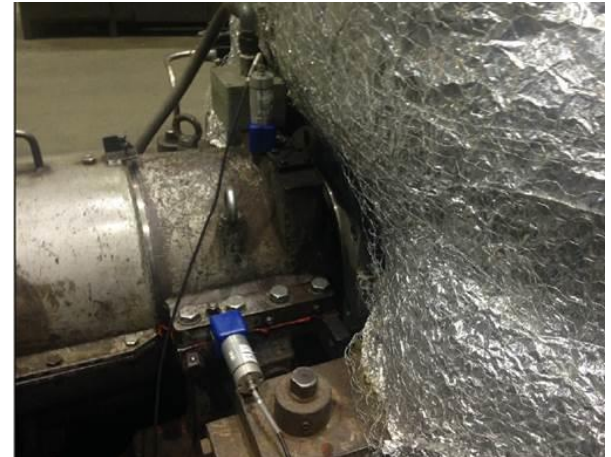
Marks, flaws and... corrosion
